HOOSAC STORES MODERNIZATION

FEASIBILITY STUDY, SUBMISSION #1 DRAFT FOR INTERNAL REVIEW FEBRUARY 7, 2020

HOOSAC STORES FEASIBILITY STUDY FOR HOOSAC STORES MODERNIZATION

115 CONSTITUTION ROAD CHARLESTOWN, MA 02129

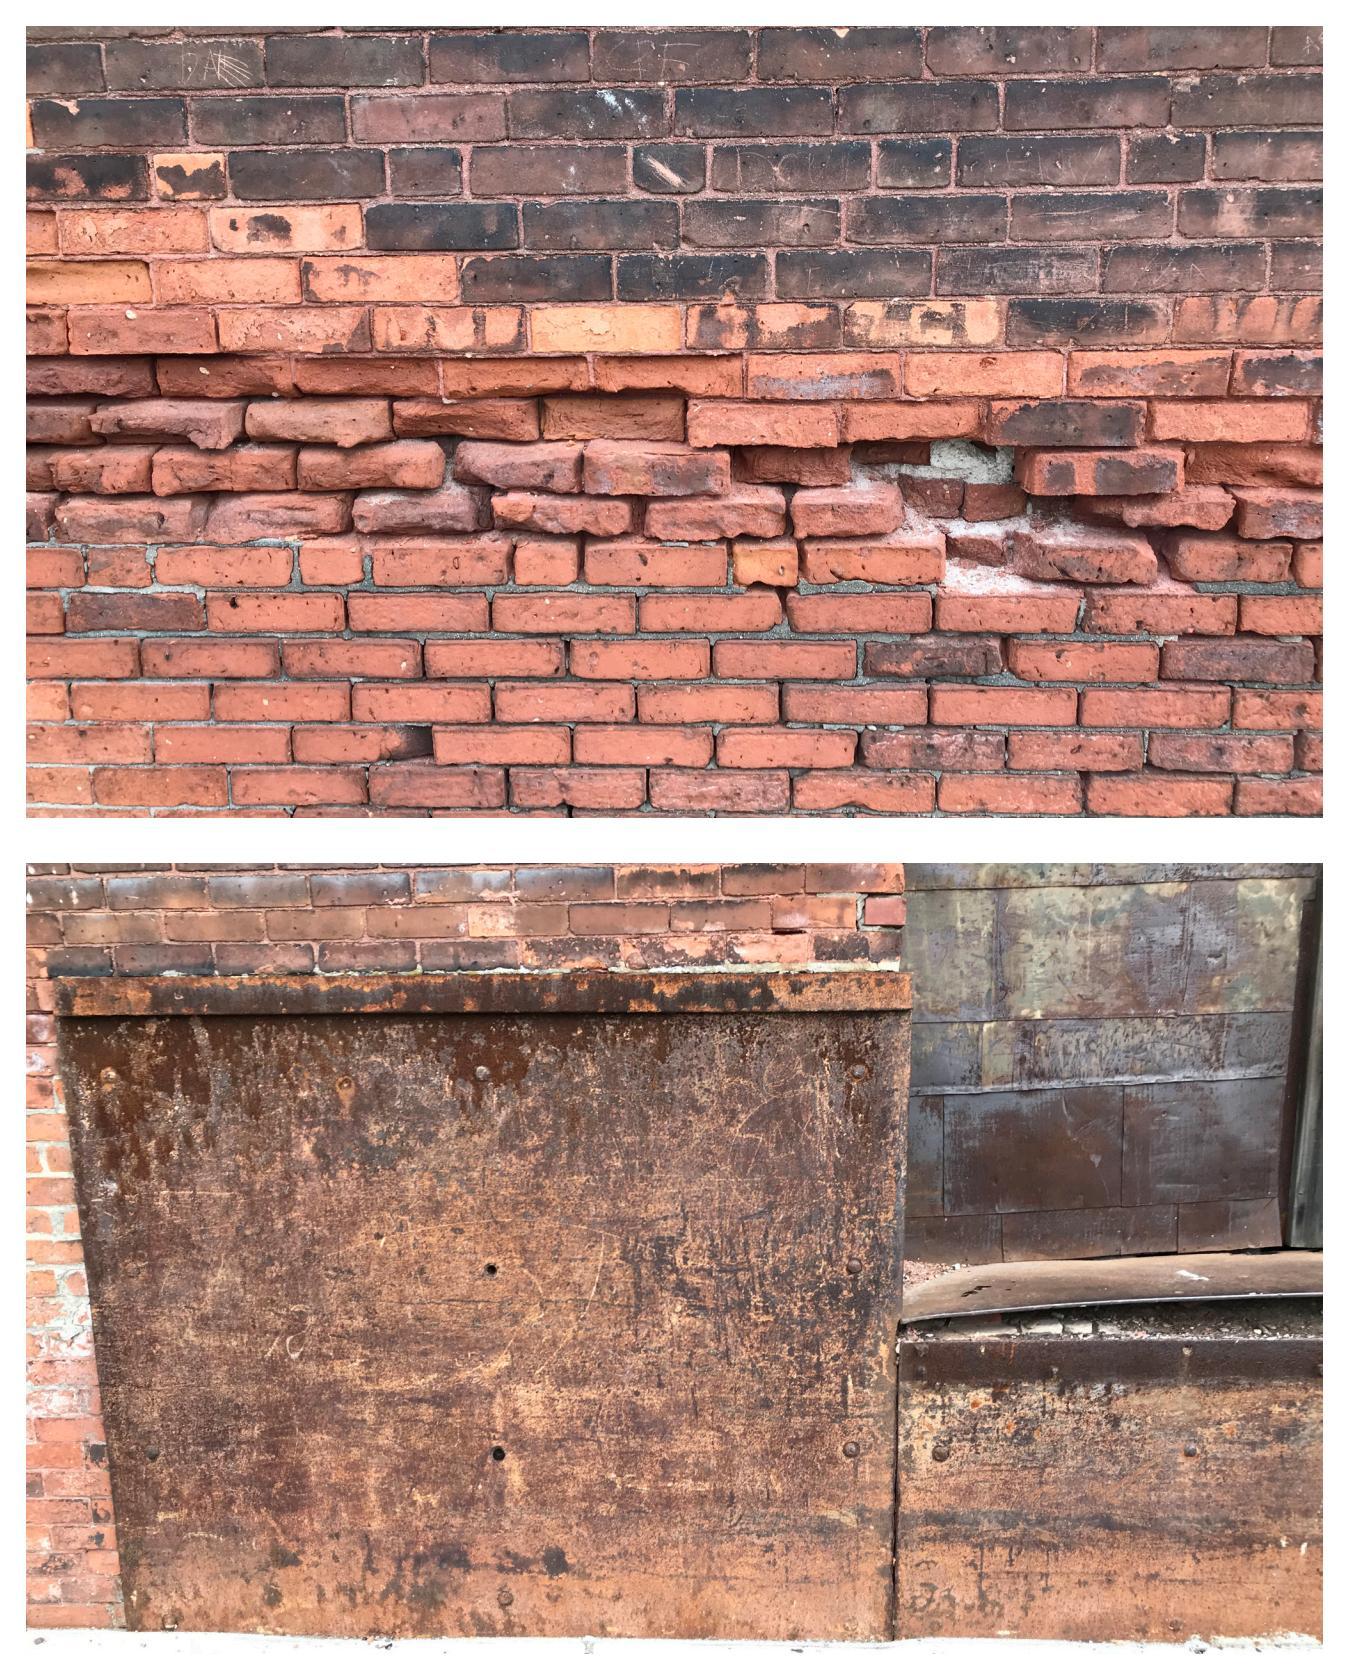
The consultant team also found the loadbearing masonry walls, despite localized areas of deterioration, were in generally good shape, with the inner wythes of brick relatively intact and sound and with a compressive strength well above modern ASCE standards.

Portions of the existing Hoosac Stores building exterior facade

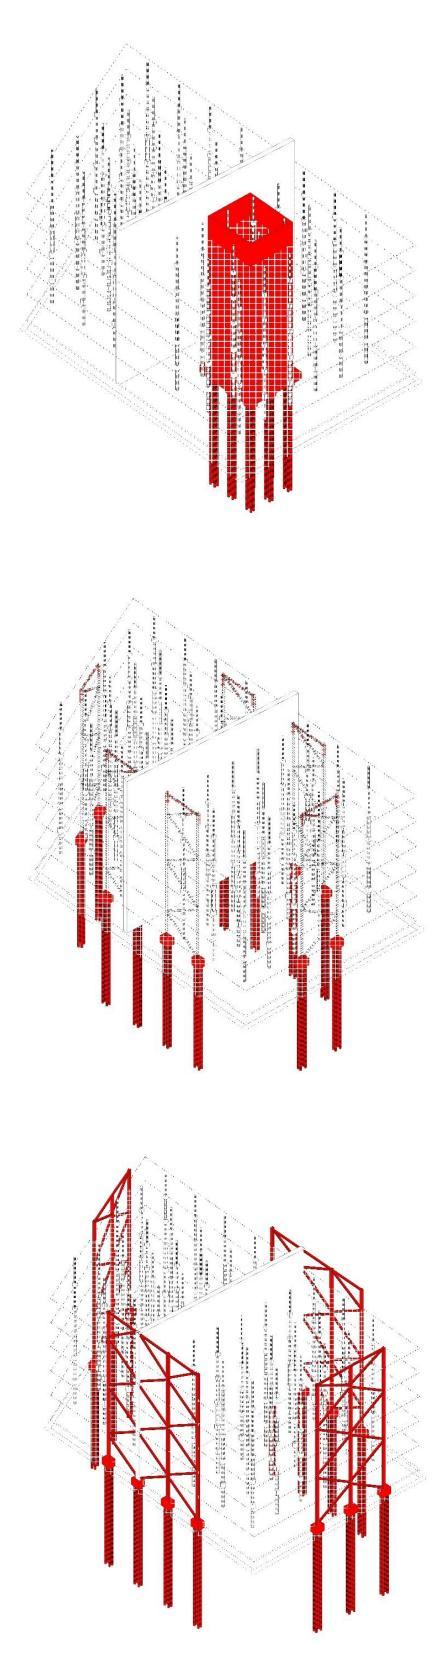
However, because the loosely laid granite stones are not anchored together, the existing footings have minimal capacity to resist lateral loads (such as wind loads or seismic loads). Any new construction would require a retrofit for lateral stability. Jacobs outlines several approaches to this problem in their report.

Suggested approaches to lateral stability of existing Hoosac Stores

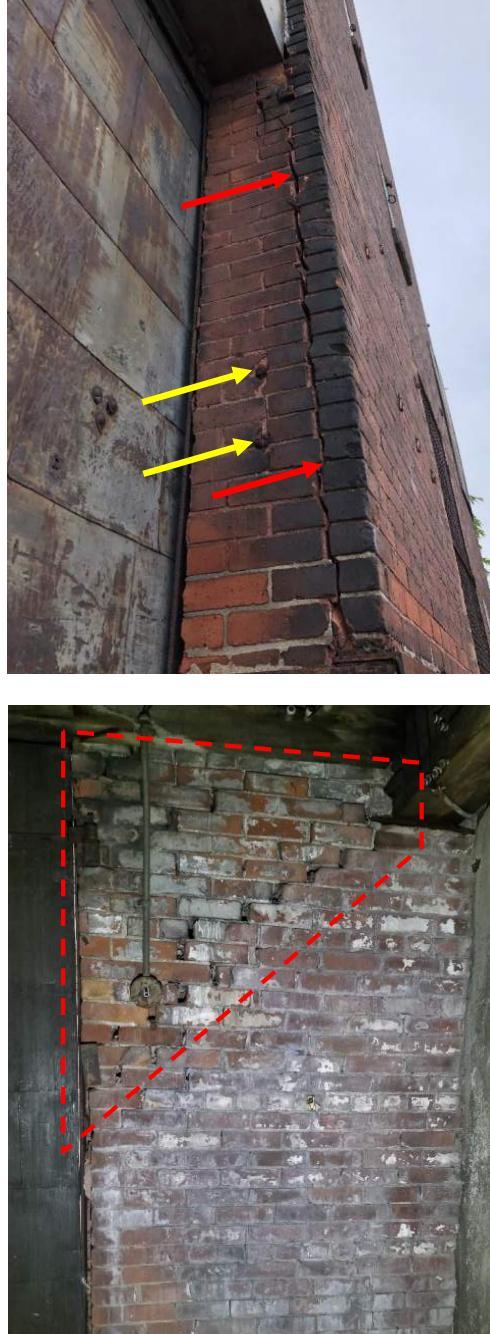
Cracked brick (red arrows) at door return (north elevation). Embedded steel (yellow arrows).

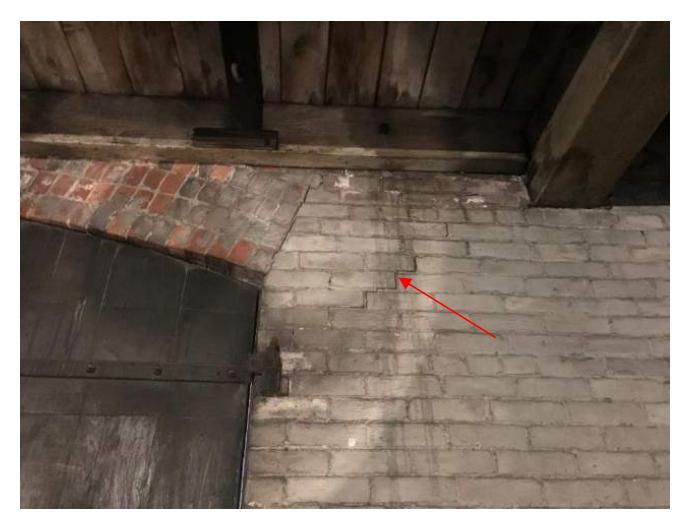
Photo 15

Cracked and bulged brick at interior (red) adjacent to door.

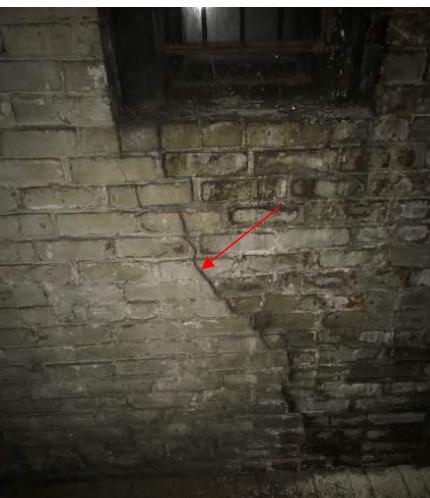
Example of cracked mortar joints (red arrows) at head of doorway.

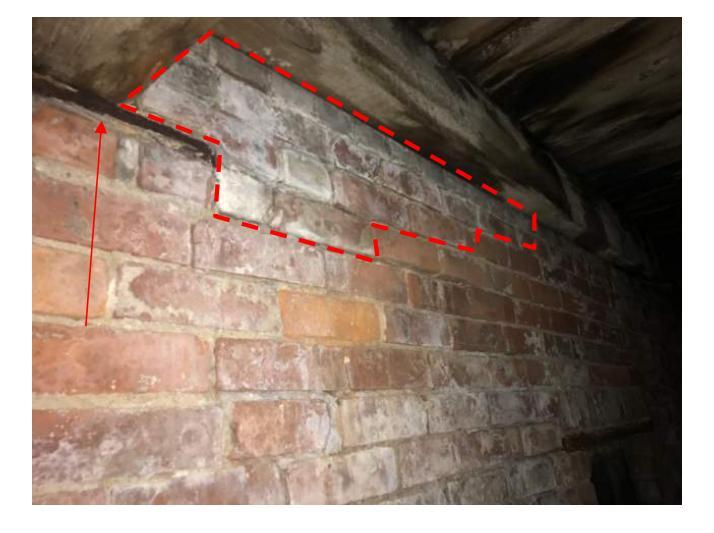
Photo 17

Example of cracked brick and mortar joints (red arrows) below window sills.

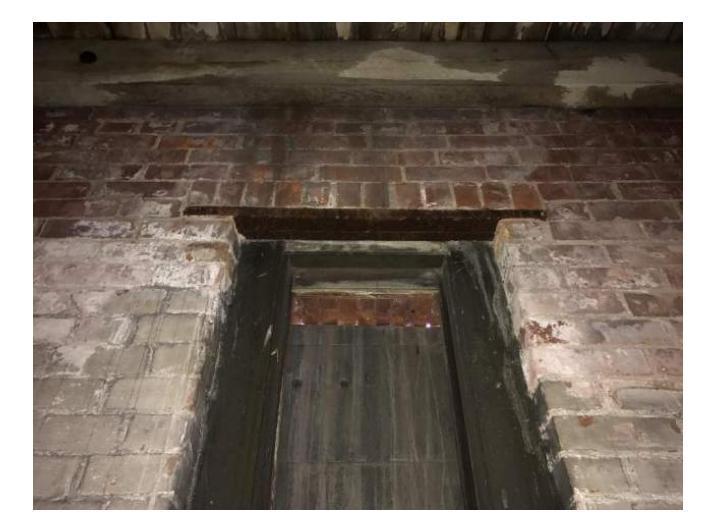
Photo 18

Brick is bugled and mortar joints are cracked (area indicated in red) adjacent to corroded metal bearing plates (red arrow), where timber beams extend into the exterior masonry wall.

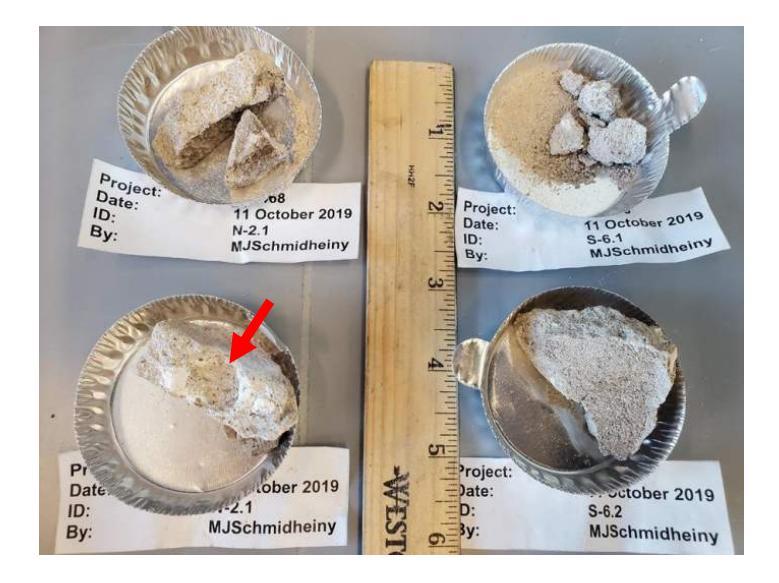
Overview photo of the mortar fragments selected for examination. The red arrow marks a particularly large rounded inclusion of light-colored, friable material in a mortar fragment from Sample W-2.1.
