Significance: Building 21, the Carriage House, is significant for its association with the Commandant's House, its probable authorship by Alexander Parris. Until the 2014 roof collapse, it was the Charlestown Navy Yard's the oldest surviving granite structure. Unreconstructed, it is unlikely to convey anything other than its plan extent and historic granite wall material.

Building Description

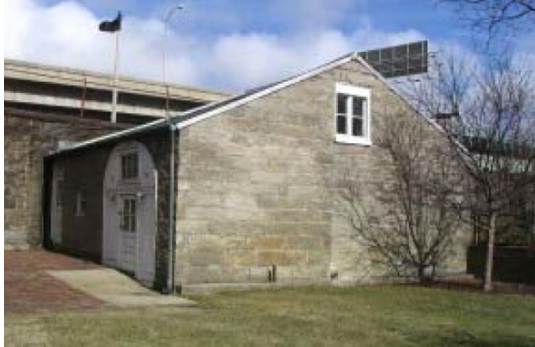
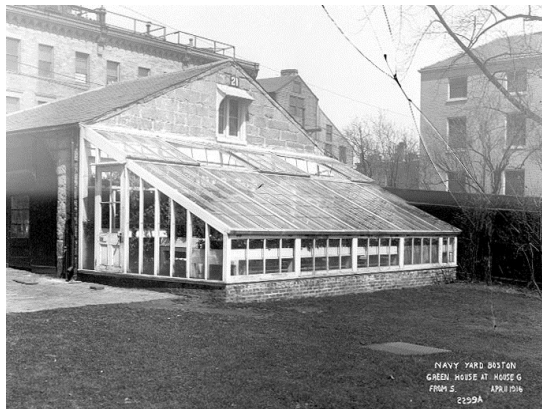
- Gross Square Feet: 1,302
- Number of Floors Above Ground: 1 1/2
- Building Height: 20 feet
- Status: Abandoned
- Current Use: None – Collapsed

In 2014 heavy snow caused the roof to cave in which damaged the roof and wall facing the Commandant's Mansion.

Building 21 is no longer intact apart from vulnerable portions of its granite walls.

Building 21 is a ruin without enclosure from weather or security from inquisitive visitors to the Park. The plan is marked by existing walls, some of which are retaining earth.

Unsalvageable ruin with potential danger to intruders.
