HOOSAC STORES MODERNIZATION

FEASIBILITY STUDY, SUBMISSION #1 DRAFT FOR INTERNAL REVIEW FEBRUARY 7, 2020

HOOSAC STORES FEASIBILITY STUDY FOR HOOSAC STORES MODERNIZATION

115 CONSTITUTION ROAD CHARLESTOWN, MA 02129

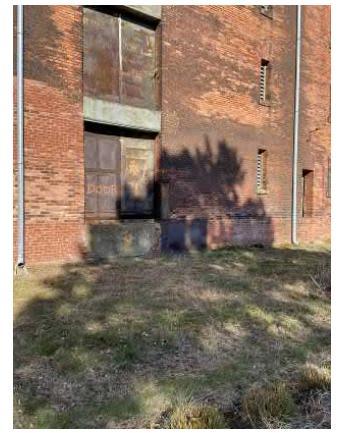
Photo 10

Photo shows an exterior view of the southern of the building.

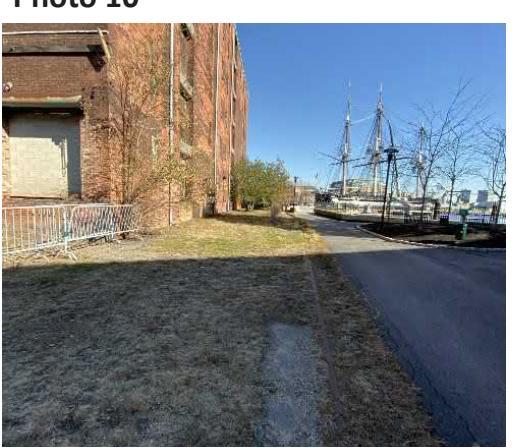
Photo 11

Photo shows the southern corner and read portion of the Hoosac's building. The grassy area is where the former Fitchburg Railroad lay and the USS Constitution is pictured in the right corner.

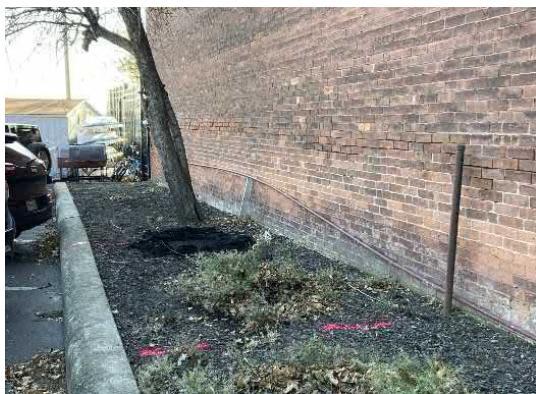
Photo 12

Photo shows the eastern exterior of the building. The pink paint is to indicate an unknown underground utility extending from the building.

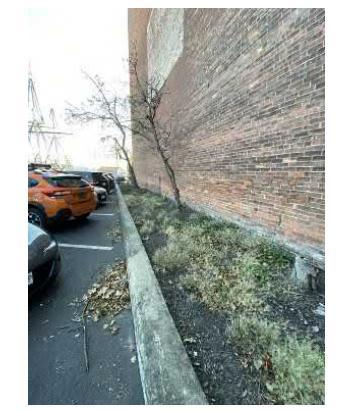
Photo shows a larger view of the eastern exterior portion of the building.

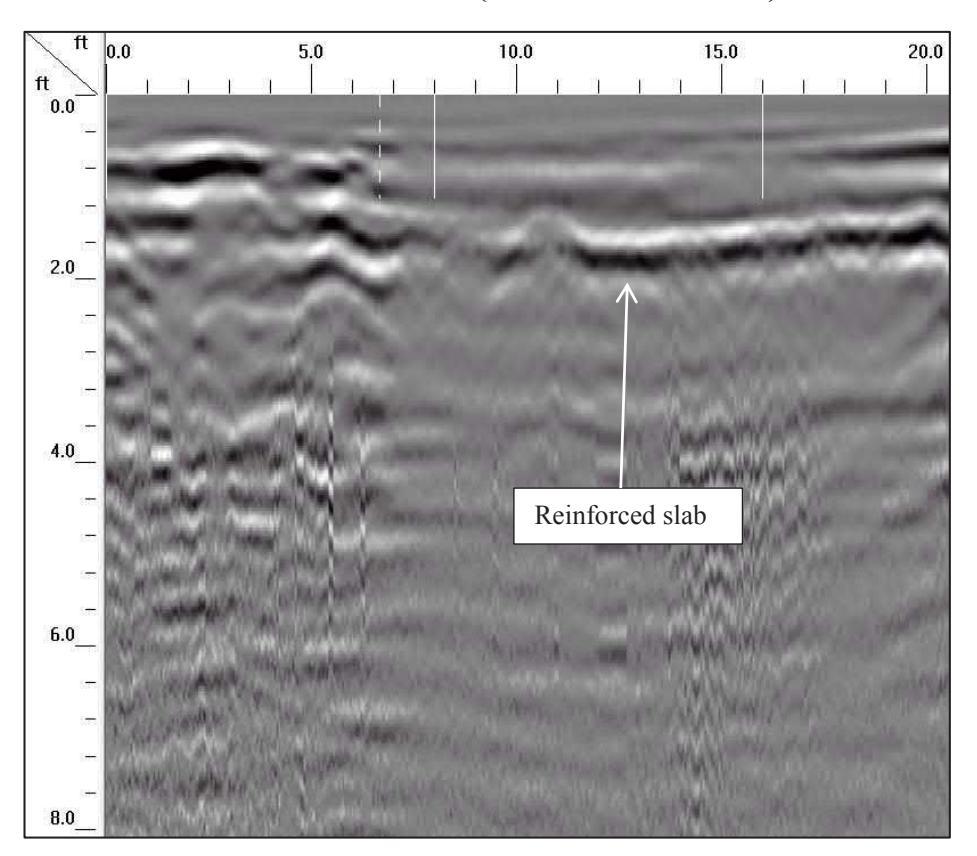
GPR Transect 1 West across A1 (steel reinforced slab)

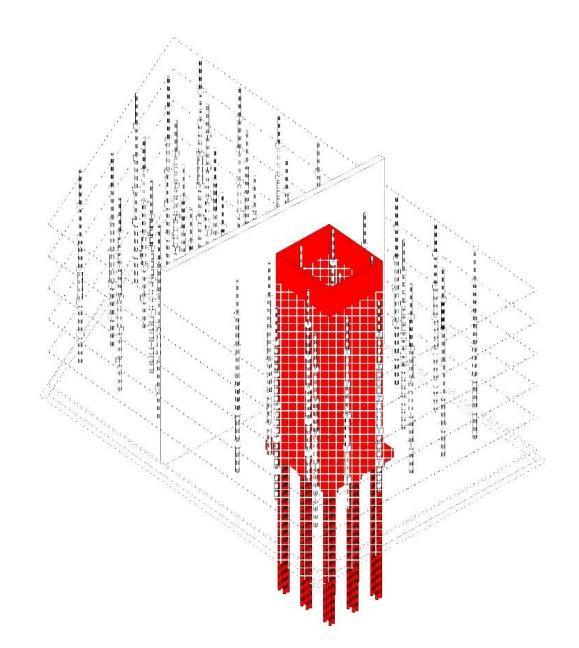
Fig. 12.1 : Strategy 1

This Strategy consists of adding four new concrete shear walls between existing building columns. This option provides a dramatic improvement on the torsional behavior of the building, and can be constructed in phases to limit the disruption of the current building configuration.

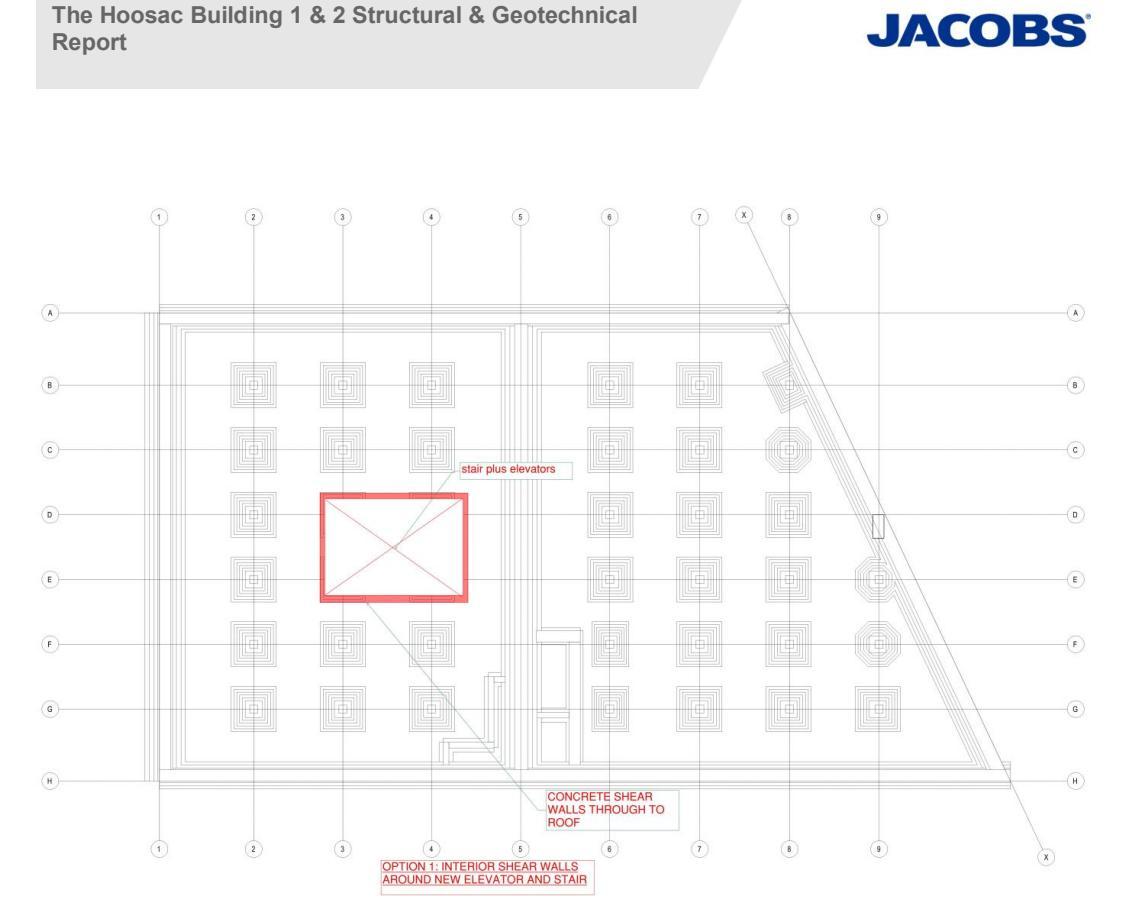
Fig. 12.2 : Strategy 1 plan indicating new interior concrete shear walls around an elevator and stair core.

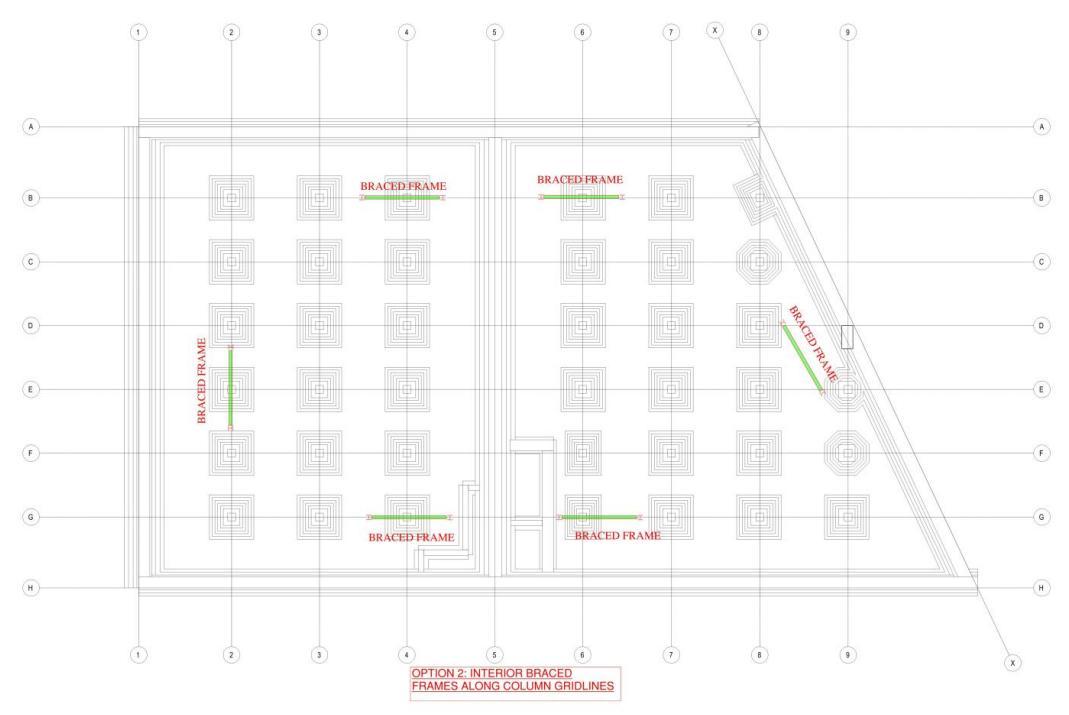
Fig. 12.4 : Strategy 2 plan indicating new braced frame structure inside the existing column grid.

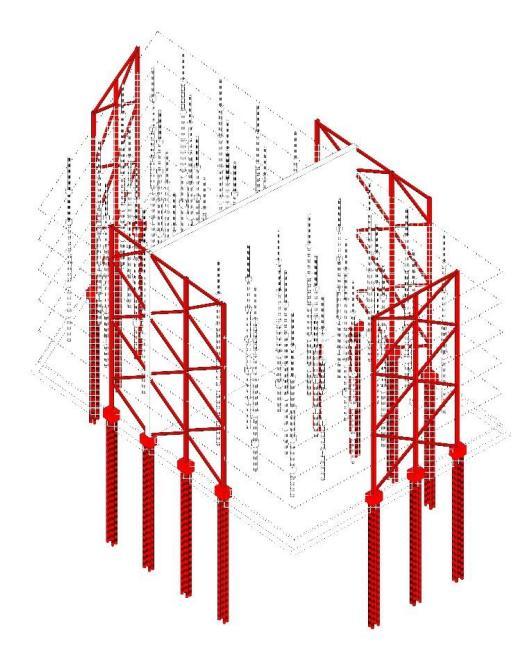
Fig. 12.5 : Strategy 3

This option proposes to add new structural steel braced frames on each of the four sides of the building. The new steel columns will line up with the existing interior face of the exterior brick walls. The new steel columns will be supported at the ground level by new micro-piles that extend to the appropriate soil strata so as to transfer forces from the braced frames into foundation.

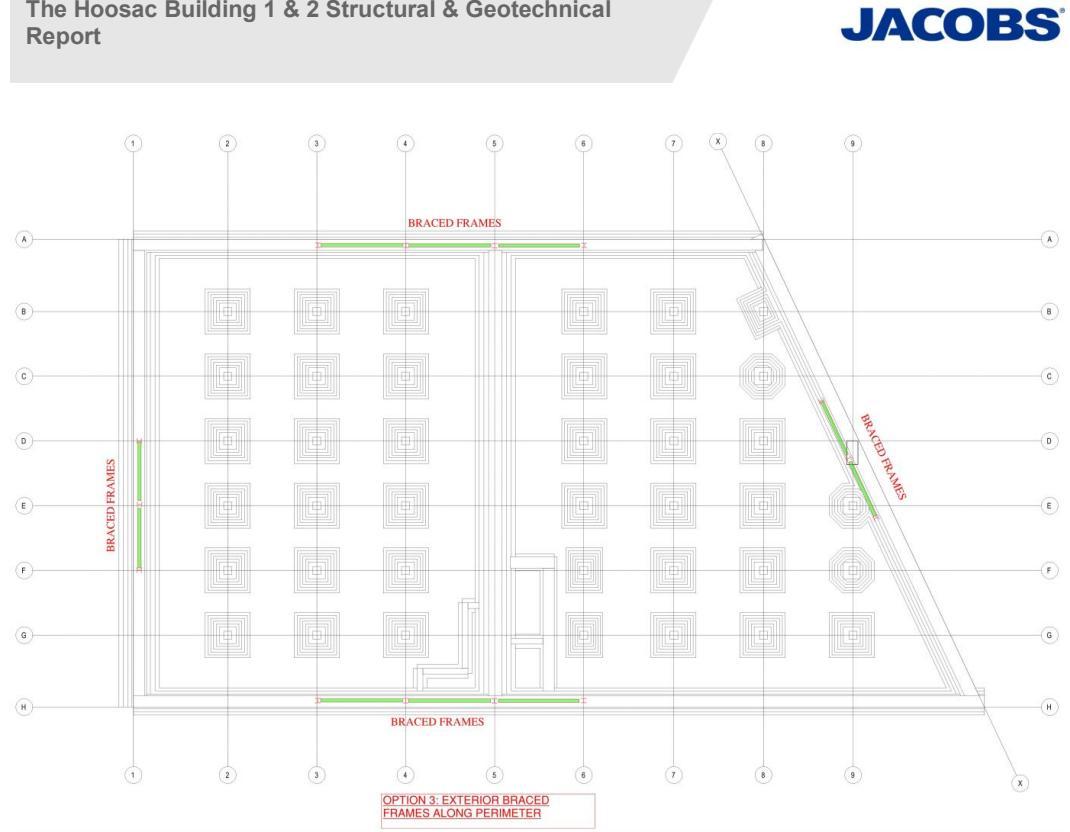
Fig. 12.6 : Strategy 3 plan indicating an exterior braced from along the perimeter of the building.

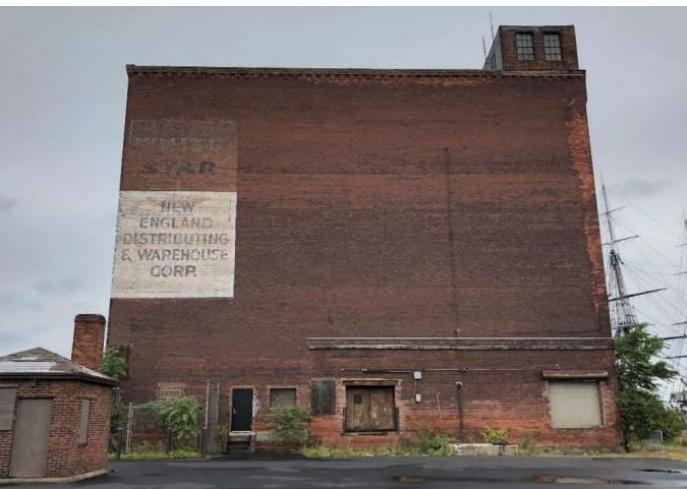
Photo 2

Hoosac building – west elevation.

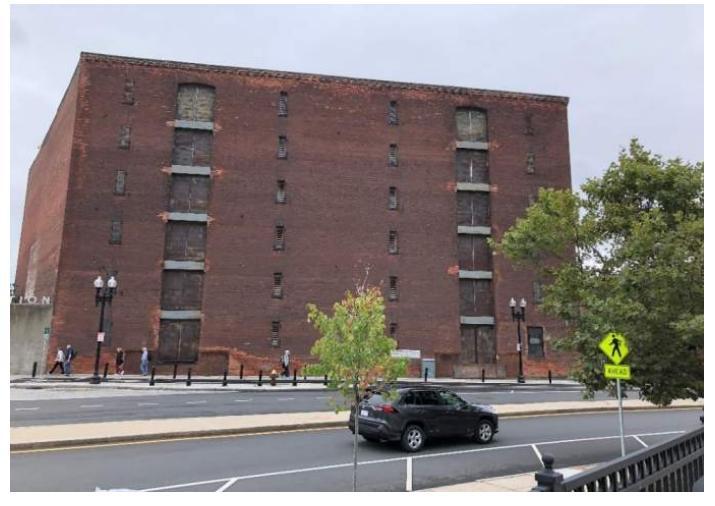
Photo 3

Hoosac building – north elevation.

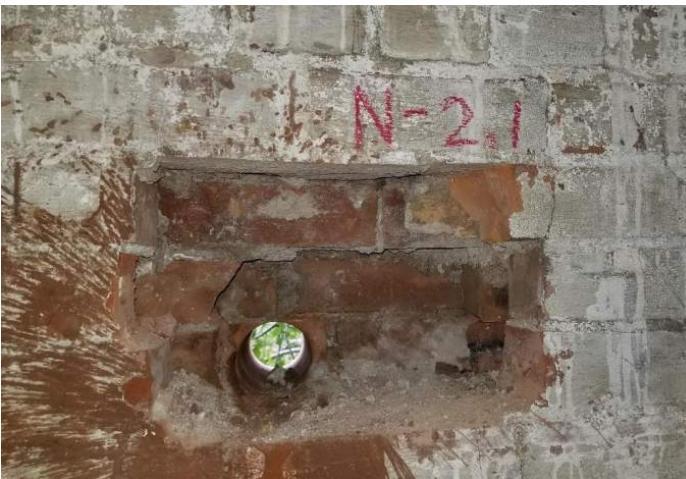
Photo 5

We observed twelve masonry cores through the full-depth of the exterior load-bearing masonry walls and reviewed concealed conditions at twelve masonry openings (Photo 5) at the interior to confirm the thickness of the wall and extract brick and mortar samples from the interior and middle wythes for laboratory testing (refer to Sections 4.1 and 4.2). We collected a mortar sample from the collar joint between the inner and middle wythe at each masonry opening. Masonry core and exploratory opening locations are indicated on Sheets A1 – A4 (exterior elevations) and Sheets A18 – A21 (interior elevations) on Appendix A (attached).

Example of an exploratory opening in the exterior masonry wall and full-thickness core, each of which was conducted by the assisting contractor from the interior. Opening N2.1 shown, others similar.

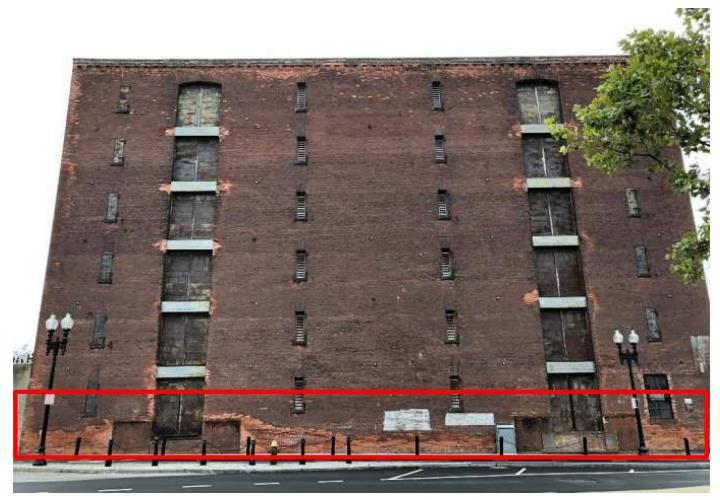
Photo 6

The masonry within 4 ft of grade is typically eroded at all elevations, and erosion is most severe at the north elevation, where the building is adjacent to a public sidewalk (Photos 6 and 7). There are several locations where the outer wythe of brick is missing at or near grade. Eroded brick and mortar joints are also present on all elevations well above from grade, particularly at the south elevation (Photo 8). Eroded and face-spalled brick is bright orange in color where it's lost its fire-skin and surface soiling.

Eroded brick and mortar joints near grade (red) at the west elevation.

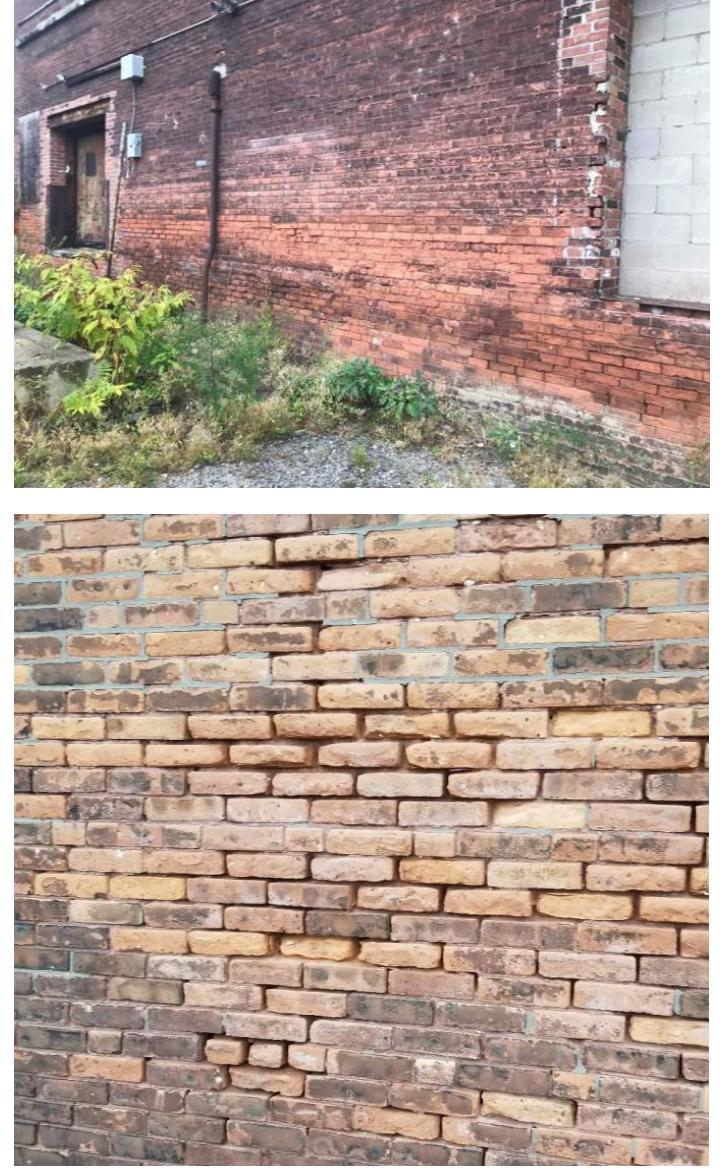
Eroded brick and mortar (orange) at the east south elevation.

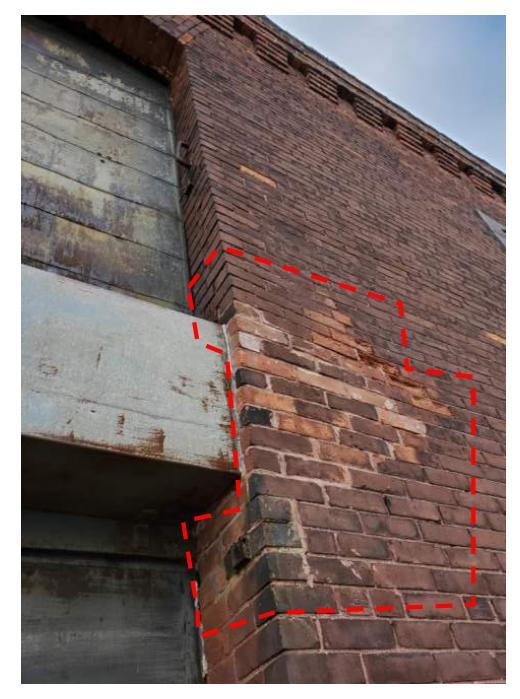
Photo 9

We observed several locations where brick masonry is displaced out-of-plane (i.e., bulged outward) with respect to the adjacent masonry, particularly adjacent to openings at the north and south elevations (Photos 9 and 10, respectively). Eroded and displaced brick masonry is also typically present below the roof level (i.e., at the parapet on the east, north, and west elevations, and below the gutter at the south elevation; Photo 11). Brick masonry adjacent to doors at the east and west elevations is previously rebuilt in many locations (i.e., the brick and/or mortar does not match the color and texture of the surrounding masonry). In many locations, bulged brick masonry is present at previously rebuilt areas (Photo 10).

Example of bulged brick masonry at door jamb (indicated in red). North elevation shown.

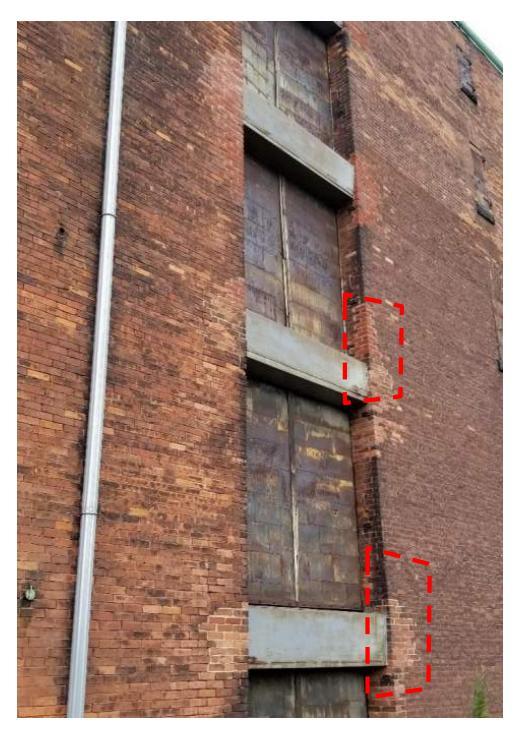
Photo 10

Example of bulged brick masonry at previously rebuilt areas (indicated in red). South elevation shown.

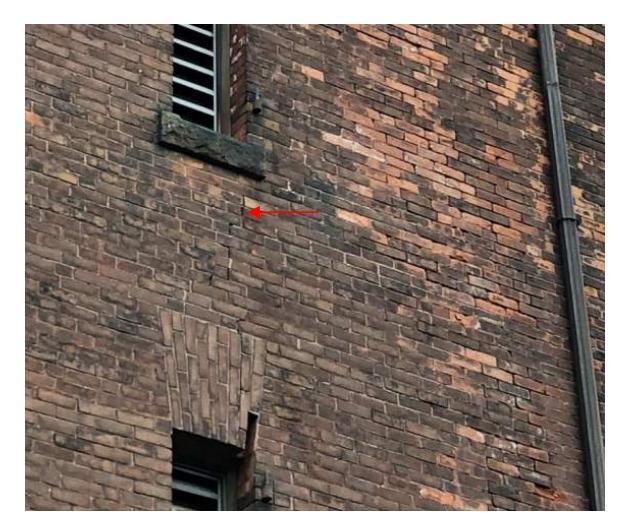
Example of eroded and bulged brick (indicated in red) below gutter at south elevation.

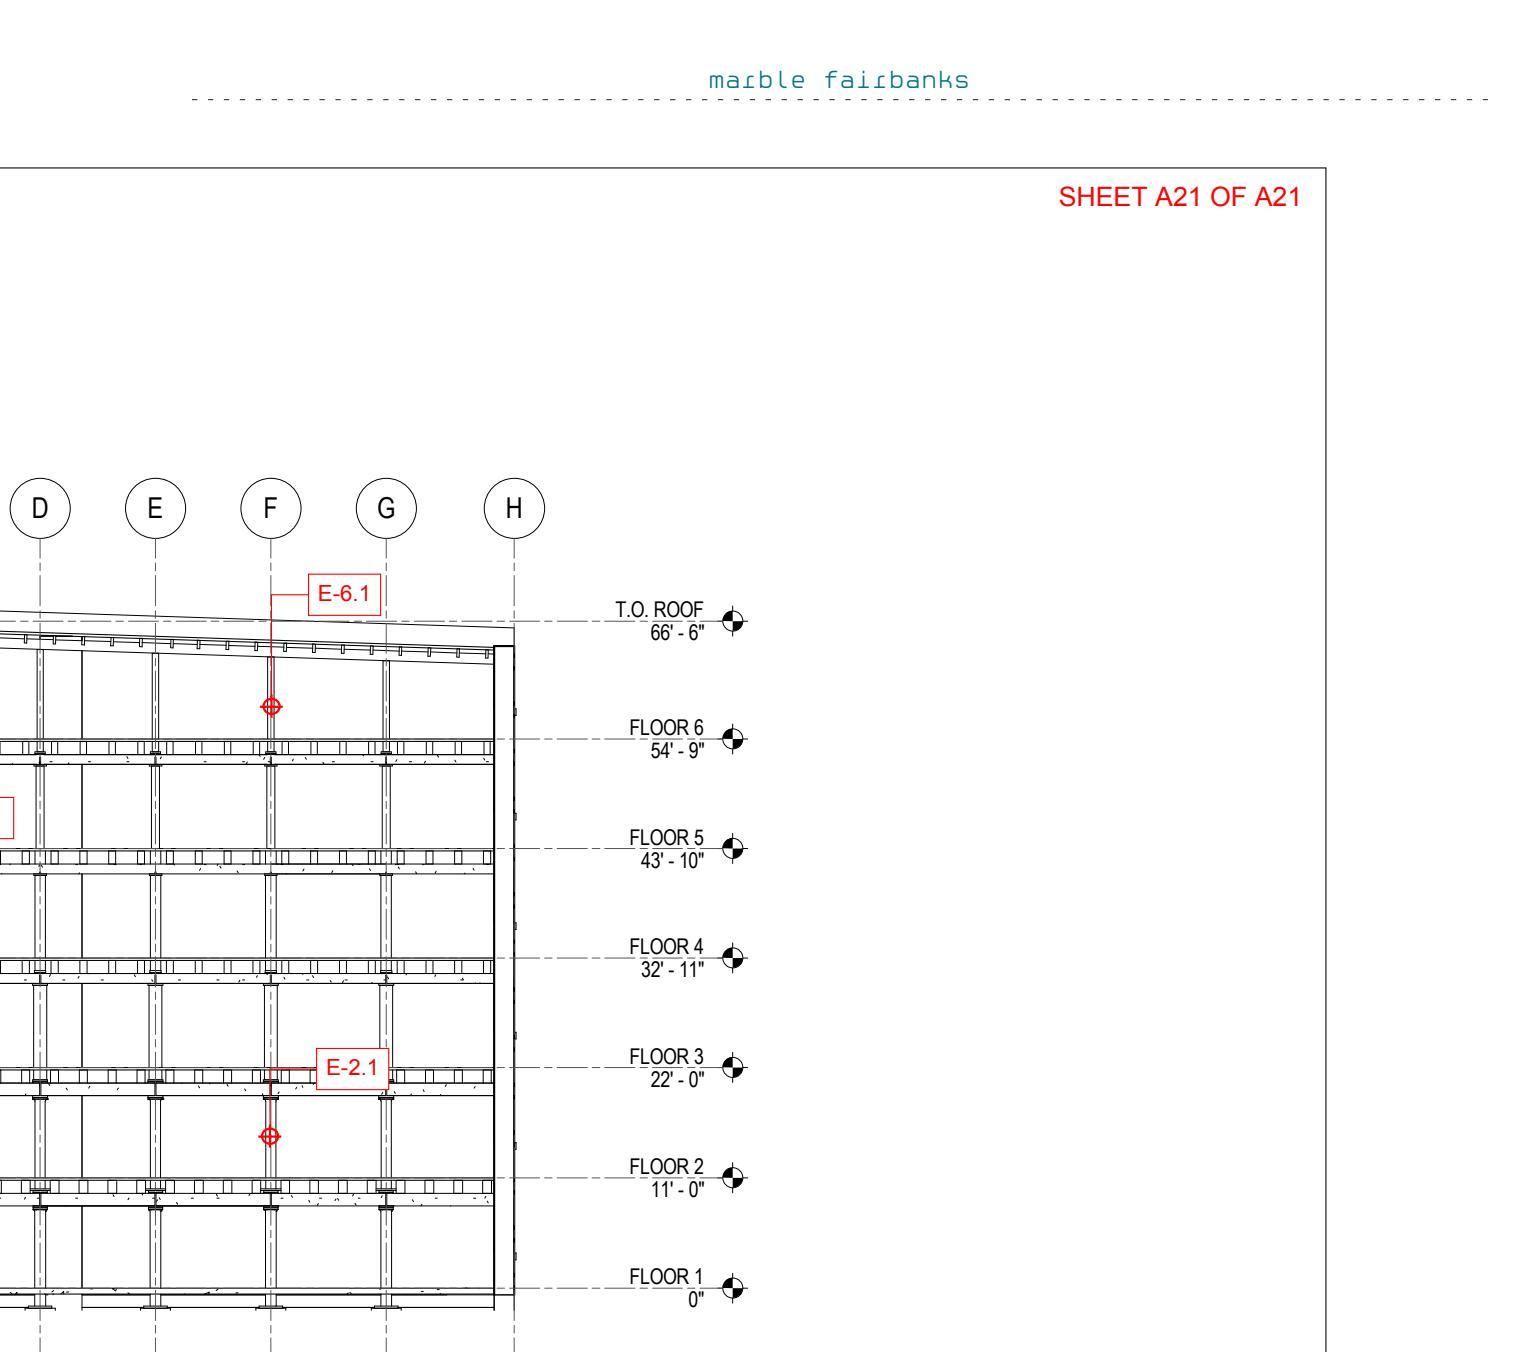
Project: Feasability Study - Hoosac Building			
	Engineering of Structures and Building Enclosures impson Gumpertz & Heger Inc. 80 Totten Pond Raod Valtham, Massachusetts 02451 www.sgh.com		Title: East Elevation - Interior			
Simpson Gumpertz & H 480 Totten Pond Raod Waltham, Massachuse			Drawn: Author	Checked: Checker	Approved: Approver	Project No.: 191468.00

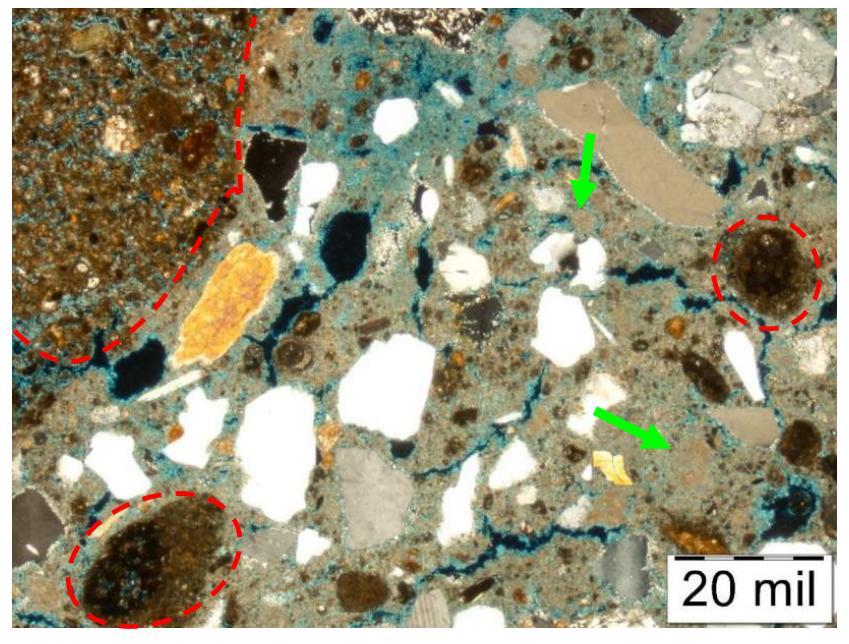
Thin section photomicrograph of Sample N-2.1, depicting the typical microstructure, including anomalous inclusions containing natural cements (bounded by red dashed lines), lime masses (green arrows), and partially carbonated binder primarily composed of hydrated lime. Note the variable porosity of the binder structure, as indicated by the variable saturation of blue-dyed epoxy used in thin section preparation.

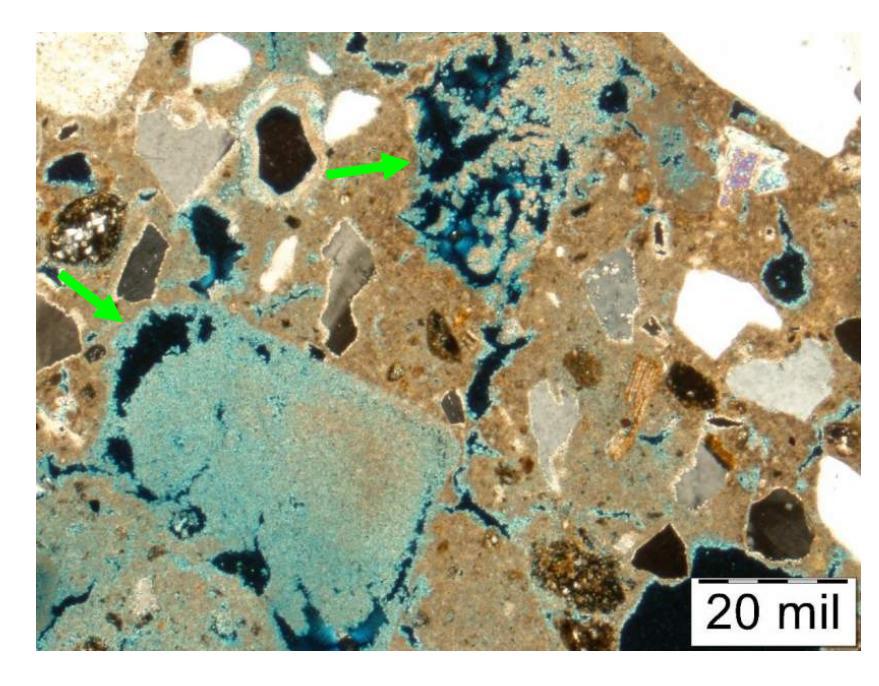
Thin section photomicrograph of Sample S-6.1, depicting the typical microstructure, including relatively large, partially reacted lime masses (green arrows) in a carbonated lime binder.

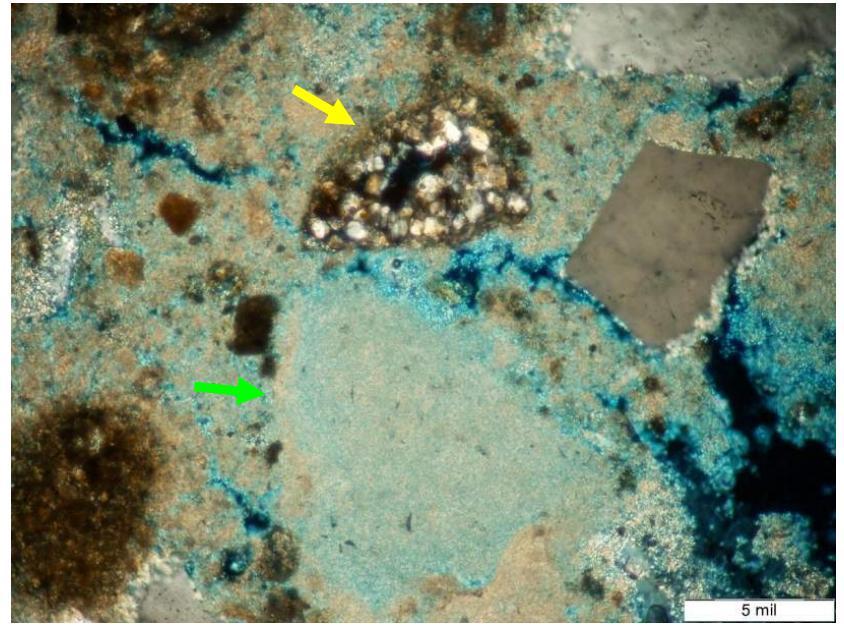
Photo 8

Photomicrograph of Sample W-2.1, showing a small cluster of belite particles (yellow arrow) and a lime mass (green arrow) in a lime binder.

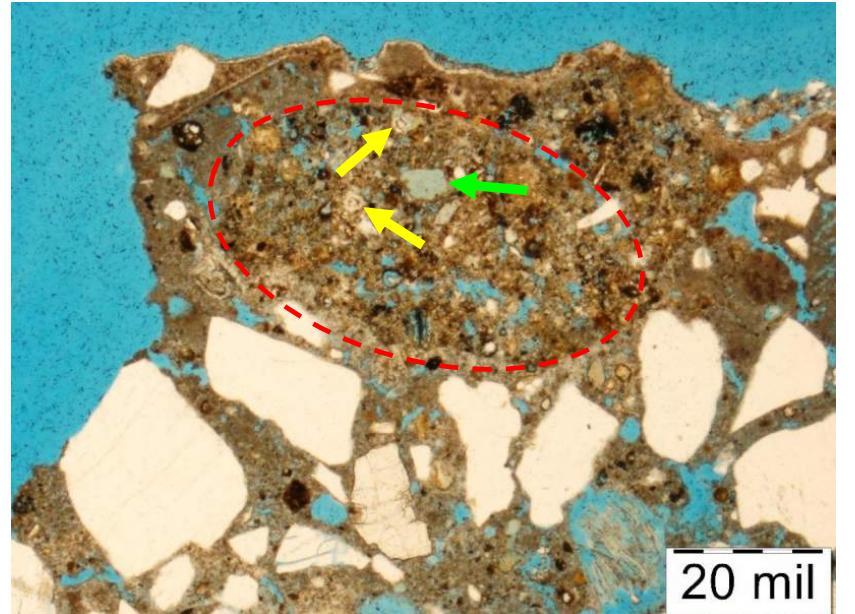
Photo 9

Thin section photomicrograph of Sample S-6.2, depicting an anomalous inclusion (encircled by red dashed line) containing possible alite particles with hydration rims (yellow arrows) and lime masses (green arrow).
